# Manhole Inspection Summary

Manhole # S37Q\_\_032MH

Insp Date: **4/2/09 9:27 AM**

**Location** Address: **1157 RIVERSIDE AV**

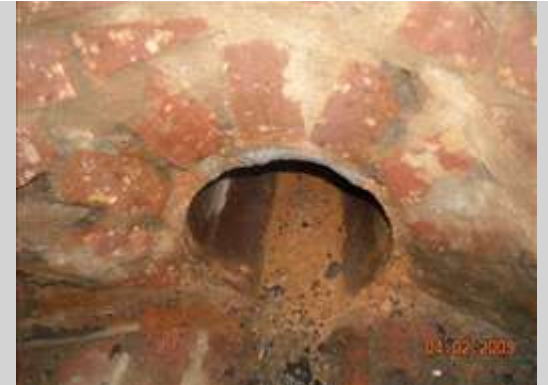
12 O'Clock Outflow

8 in. Circular Gravity Sewer  
Pipe Out @ 12 O'Clock

Infiltration: **None** Pipe Seal Cond: **Sound**
